February 27, 2018

08340 Version 2

2014–17 Odyssey: Judder from the Torque Converter Lock-Up Clutch (Snapshot Upload Required)

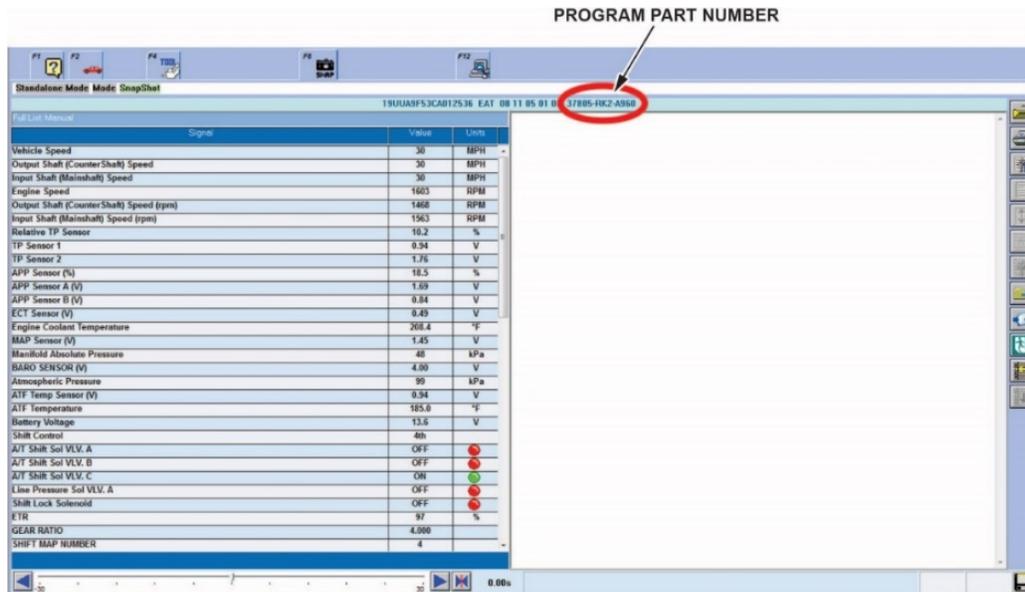
1. Connect the i-HDS, and go to the A/T Data List. Check the program P/N.

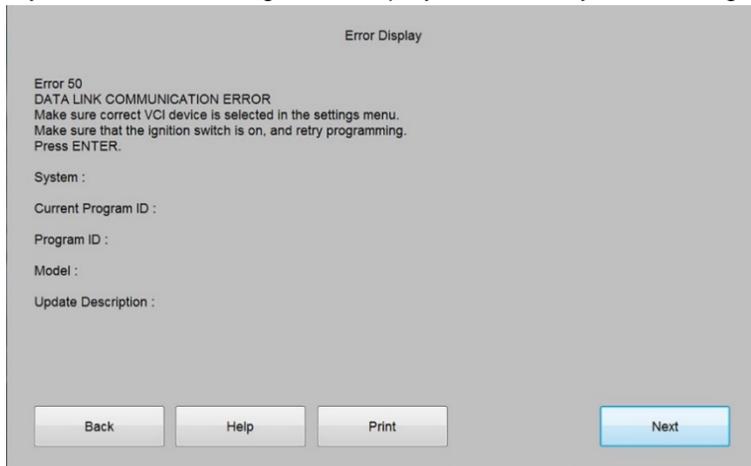
- You can't update the vehicle using the MVCI as a standalone tool.
- **Do not** use the MongoosePro VCI tool.
- Make sure the 12 volt battery is fully charged before starting an update.
- Connect a fully charged jumper battery to the vehicle and leave it connected during the entire procedure to maintain steady voltage.
- Never turn the ignition to OFF or ACCESSORY during the update. If there is a problem with the update, leave the ignition turned to ON.
- To prevent PCM damage, do not operate anything electrical (headlights, audio system, brakes, A/C, power windows, door locks, etc.) during the update.
- If you see the following Error Display, check that you are using the correct tool (MVCI or DST-i) with the i-HDS.

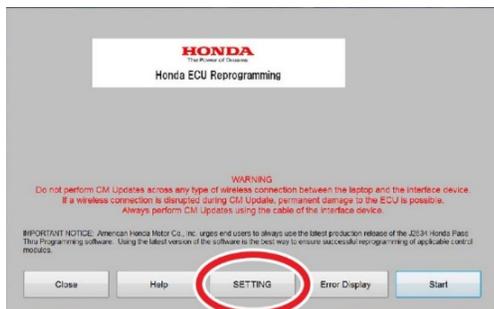
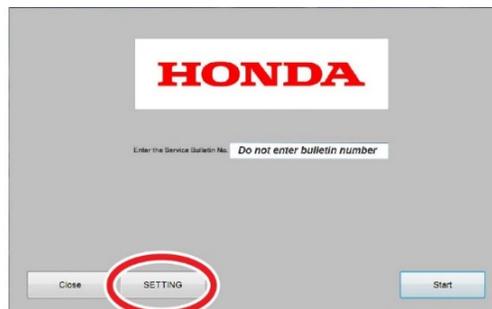
To change this, click on either of the SETTING selection buttons at the bottom of the J2534 initial screens as shown.

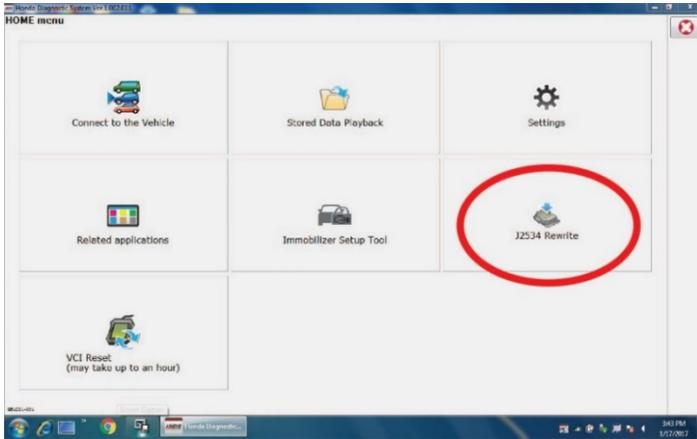
2. Select **J2534 Rewrite**.

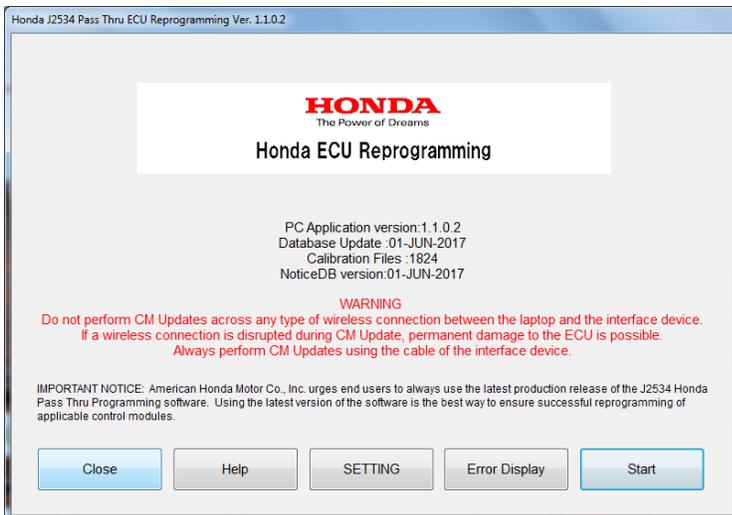
3. Confirm the software is the same **or later** as listed in SOFTWARE INFORMATION.

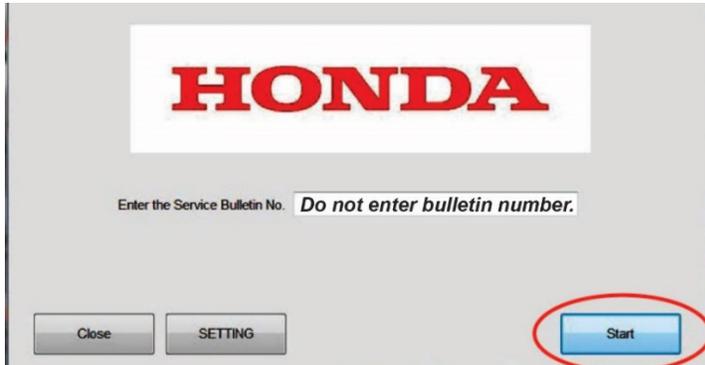
4. Select **Start**, then follow the screen prompts.

- **Don't enter a bulletin number.**
